**Flood Control Project Maintenance  
Levee Inspections**

## Maintenance Issue Types Only, Levee Inspection Report By Mile - Spring 2018

### Sutter Maintenance Yard East-West Interceptor

Waterway	Bank	Unit Miles	Inspection Start/End	Inspector
Unit No. 01 West Levee	Right	1.75	03/28/2018 03/28/2018	Bob Duffey

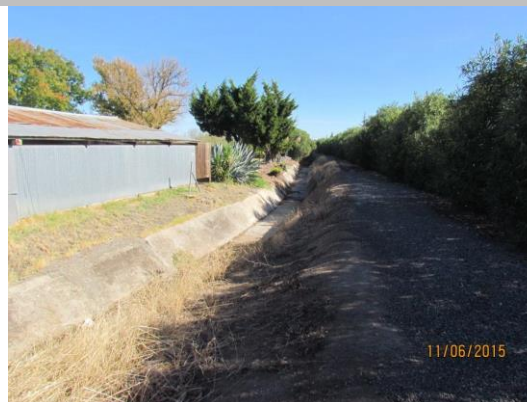
Photo 1 of 2 : SP\_2018\_ST0020\_213\_4\_20180305\_00004.jpg

LM Start	0.62	Rating **	U	Issue No.	4
LM End	0.65	Issue Type +	Ma	Location *	WS
Category	Earthen Levee			GPS Latitude/Longitude	
				Start	End
Item	Erosion / Bank Caving			39.171292 °	39.171232 °
				-121.748868 °	-121.748175 °
DWR ID	DWR_NA0020_01_s_2012_4				
Comment Code					
E2 : Schedule repair of erosion site prior to the next inspection.					
Inspector Comment					
Repair the erosion along the concrete ditch.

View the erosion along the concrete ditch.

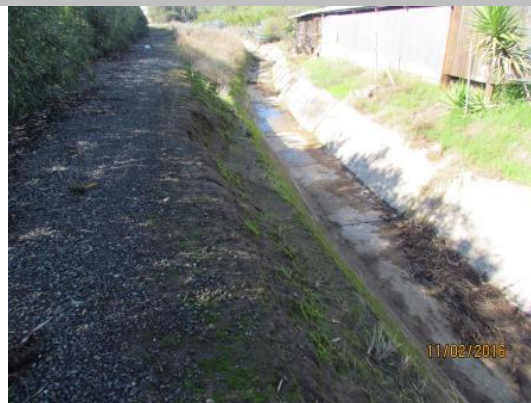
Photo 2 of 2 : SP\_2018\_ST0020\_213\_4\_20180305\_00005.jpg

LM Start	0.62	Rating **	U	Issue No.	4 (cont)	
LM End	0.65	Issue Type +	Ma	Location *	WS	
Category	Earthen Levee			GPS Latitude/Longitude		
				Start		End
Item	Erosion / Bank Caving			39.171292 °		39.171232 °
				-121.748868 °		-121.748175 °
DWR ID	DWR_NA0020_01_s_2012_4					
Comment Code						
E2 : Schedule repair of erosion site prior to the next inspection.						
Inspector Comment						
Repair the erosion along the concrete ditch.

Another view the erosion along the concrete ditch.

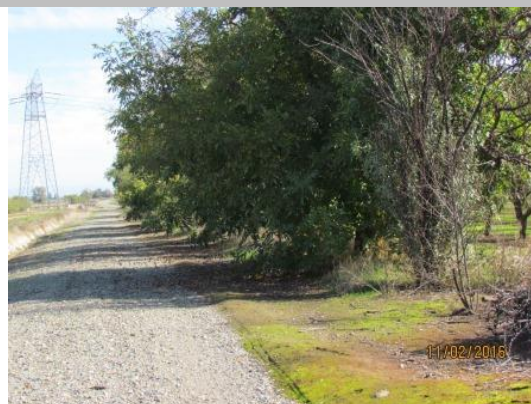
Photo 1 of 1 : SP\_2018\_ST0020\_213\_18\_20180305\_00012.jpg

LM Start	1.11	Rating **	M	Issue No.	18	
LM End	1.28	Issue Type +	Ma	Location *	LS	
Category	Earthen Levee			GPS Latitude/Longitude		
				Start		End
Item	Trim / Thin Trees			39.171283 °		39.171243 °
				-121.739315 °		-121.736312 °
DWR ID	DWR_ST0020_01_f_2016_18					
Comment Code						
T1 : Trim trees to at least five feet above ground level.						
Inspector Comment

View of the trees blocking visibility.

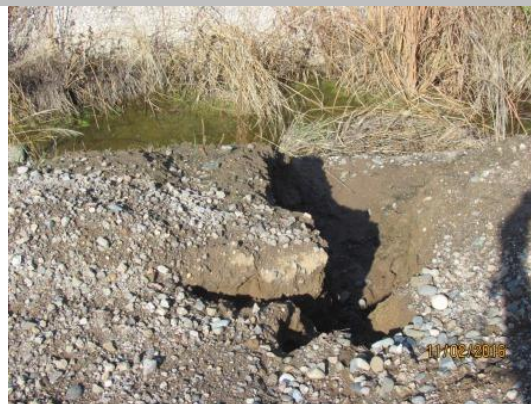
Photo 1 of 1 : SP\_2018\_ST0020\_213\_22\_20180305\_00015.jpg

LM Start	1.33	Rating **	M	Issue No.	22
LM End	1.33	Issue Type +	Ma	Location *	WS
Category	Earthen Levee			GPS Latitude/Longitude	
				Start	End
Item	Erosion / Bank Caving			39.171218 °	39.171218 °
				-121.735258 °	-121.735258 °
DWR ID	DWR_ST0020_01_f_2016_22				
Comment Code					
E1 : Note and monitor erosion site.					
Inspector Comment

View of the erosion along the bank.

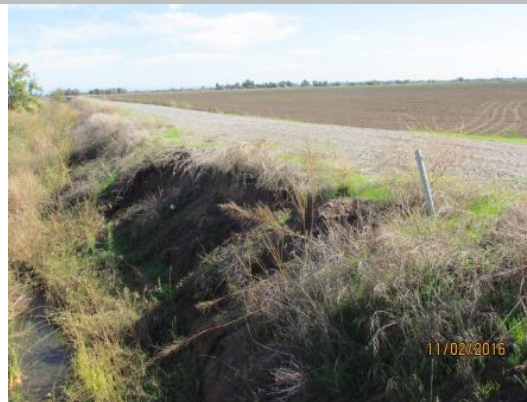
Photo 1 of 1 : SP\_2018\_ST0020\_213\_24\_20180305\_00016.jpg

LM Start	1.36	Rating **	M	Issue No.	24
LM End	1.36	Issue Type +	Ma	Location *	WS
Category	Earthen Levee			GPS Latitude/Longitude	
				Start	End
Item	Erosion / Bank Caving			39.171220 °	39.171220 °
				-121.734730 °	-121.734730 °
DWR ID	DWR_ST0020_01_f_2016_24				
Comment Code					
E1 : Note and monitor erosion site.					
Inspector Comment

View of the erosion along the bank.

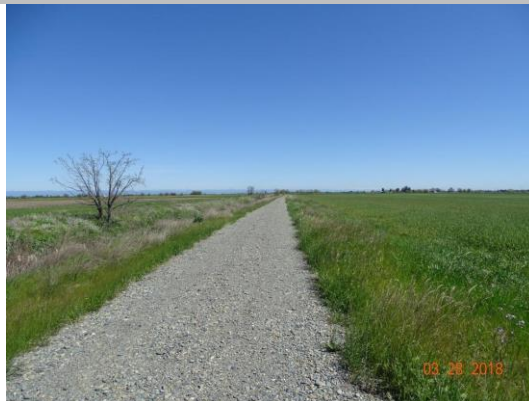
Photo 1 of 1 : SP\_2018\_ST0020\_213\_13\_20180403\_00023.jpg

LM Start	1.36	Rating **	M	Issue No.	13
LM End	1.60	Issue Type +	Ma	Location *	WS
Category	Earthen Levee			GPS Latitude/Longitude	
				Start	End
Item	Vegetation			39.171188 °	39.171110 °
				-121.734652 °	-121.730225 °
DWR ID	DWR_ST0020_01_f_2017_13				
Comment Code					
V2 : Remove the wild growth other than native grasses from the levee slopes.					
Inspector Comment					
LMA needs to maintain the native grasses on both slopes.

View of the native grasses on both slopes.

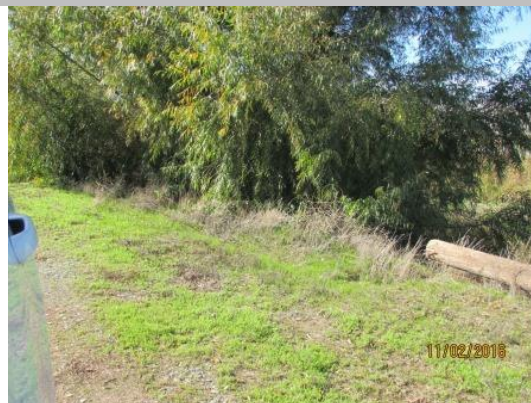
Photo 1 of 1 : SP\_2018\_ST0020\_214\_31\_20180305\_00012.jpg

LM Start	0.29	Rating **	M	Issue No.	31
LM End	0.29	Issue Type +	Ma	Location *	WS
Category	Earthen Levee			GPS Latitude/Longitude	
				Start	End
Item	Trim / Thin Trees			39.171008 °	39.171008 °
				-121.721025 °	-121.721025 °
DWR ID	DWR_ST0020_02_f_2016_31				
Comment Code					
T1 : Trim trees to at least five feet above ground level.					
Inspector Comment

View of the overgrown trees blocking visibility and access.

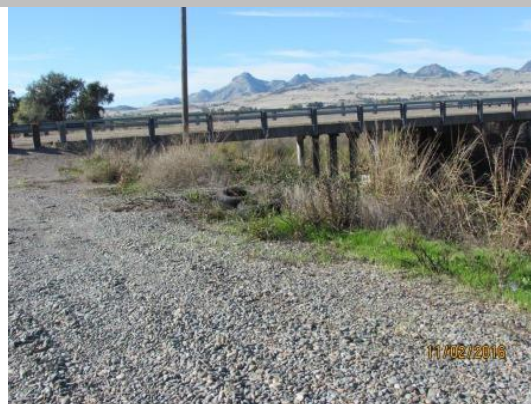
Photo 1 of 1 : SP\_2018\_ST0020\_214\_28\_20180305\_00011.jpg

LM Start	0.53	Rating **	M	Issue No.	28	
LM End	0.53	Issue Type +	Ma	Location *	WS	
Category	Earthen Levee			GPS Latitude/Longitude		
				Start		End
Item	Encroachments			39.171028 °	39.171028 °	
				-121.716475 °	-121.716475 °	
DWR ID	DWR_ST0020_02_s_2016_28					
Comment Code						
DE : Debris						
Inspector Comment						
Tires and tree clippings on w/s crown.

View of the tires along the waterside berm.

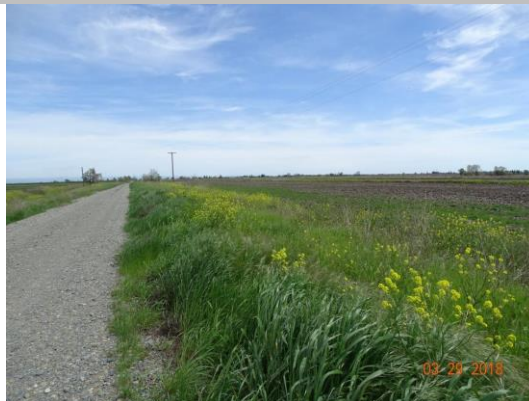
Photo 1 of 2 : SP\_2018\_ST0020\_214\_19\_20180403\_00043.jpg

LM Start	0.54	Rating **	M	Issue No.	19
LM End	1.32	Issue Type +	Ma	Location *	LS
Category	Earthen Levee			GPS Latitude/Longitude	
				Start	End
Item	Vegetation			39.171032 °	39.170853 °
				-121.716310 °	-121.701775 °
DWR ID	DWR_ST0020_02_f_2017_19				
Comment Code					
V2 : Remove the wild growth other than native grasses from the levee slopes.					
Inspector Comment					
Remove the vegetation from the landside slope.

View of the vegetation along the landside slope.

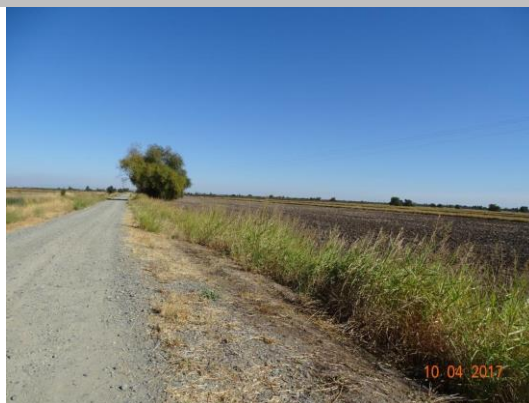
Photo 2 of 2 : SP\_2018\_ST0020\_214\_19\_20180305\_00009.jpg

LM Start	<b>0.54</b>	Rating **	M	Issue No.	<b>19 (cont)</b>
LM End	<b>1.32</b>	Issue Type +	Ma	Location *	LS

View of the vegetation along the landside slope.

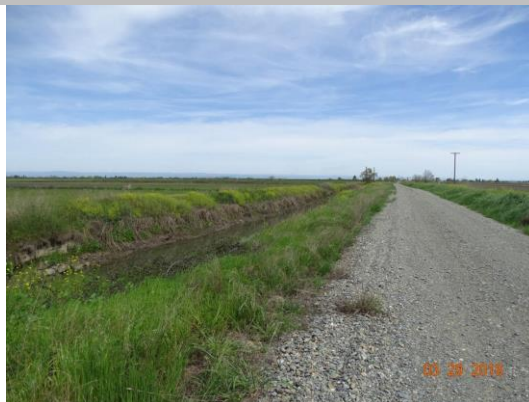
Photo 1 of 2 : SP\_2018\_ST0020\_214\_20\_20180403\_00044.jpg

LM Start	0.54	Rating **	M	Issue No.	20
LM End	1.32	Issue Type +	Ma	Location *	WS
Category	Earthen Levee			GPS Latitude/Longitude	
				Start	End
Item	Vegetation			39.171032 °	39.170853 °
				-121.716310 °	-121.701775 °
DWR ID	DWR_ST0020_02_f_2017_20				
Comment Code					
V2 : Remove the wild growth other than native grasses from the levee slopes.					
Inspector Comment					
Remove the vegetation from the waterside slope.

View of the native vegetation on the waterside slope.

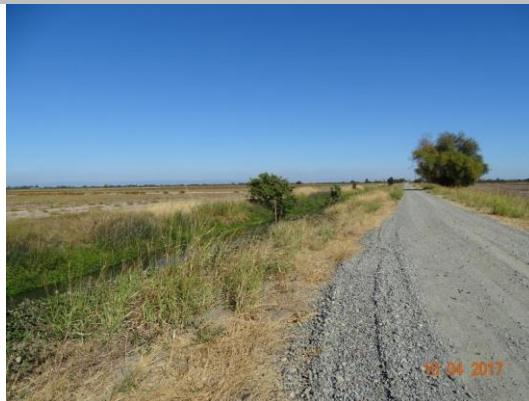
Photo 2 of 2 : SP\_2018\_ST0020\_214\_20\_20180305\_00010.jpg

LM Start	0.54	Rating **	M	Issue No.	20 (cont)	
LM End	1.32	Issue Type +	Ma	Location *	WS	
Category	Earthen Levee			GPS Latitude/Longitude		
				Start		End
Item	Vegetation			39.171032 °		39.170853 °
				-121.716310 °		-121.701775 °
DWR ID	DWR_ST0020_02_f_2017_20					
Comment Code						
V2 : Remove the wild growth other than native grasses from the levee slopes.						
Inspector Comment						
Remove the vegetation from the waterside slope.

View of the native vegetation on the waterside slope.

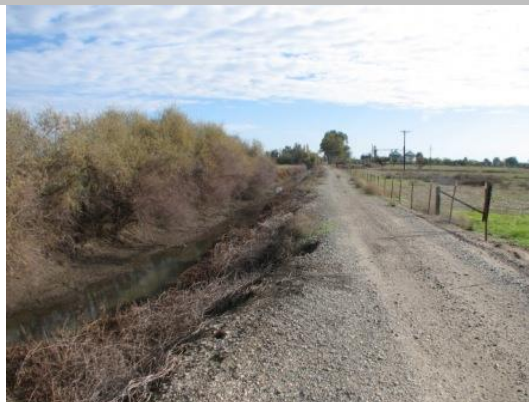
Photo 1 of 2 : SP\_2018\_ST0020\_214\_4\_20180305\_00003.jpg

LM Start	1.54	Rating **	M	Issue No.	4
LM End	2.01	Issue Type +	Ma	Location *	WS
Category	Earthen Levee			GPS Latitude/Longitude	
				Start	End
Item	Erosion / Bank Caving			39.170800 °	39.170732 °
				-121.698105 °	-121.689082 °
DWR ID	DWR_NA0020_02_s_2012_4				
Comment Code					
E1 : Note and monitor erosion site.					
Inspector Comment					
Monitor the erosion along the waterside slope.

View of the erosion along the waterside slope.

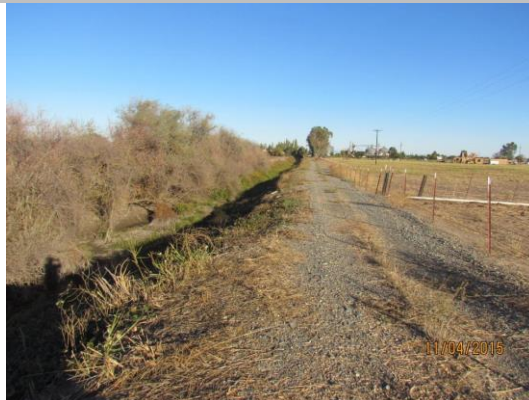
Photo 2 of 2 : SP\_2018\_ST0020\_214\_4\_20180305\_00004.jpg

LM Start	<b>1.54</b>	Rating **	M	Issue No.	<b>4 (cont)</b>
LM End	<b>2.01</b>	Issue Type +	Ma	Location *	WS

View of the erosion along the waterside slope.
